Report on the investigation of
the grounding at high speed of the leisure powerboat

Sea Snake

near the entrance to Tarbert harbour, Loch Fyne

Report No 10/2006
March 2006

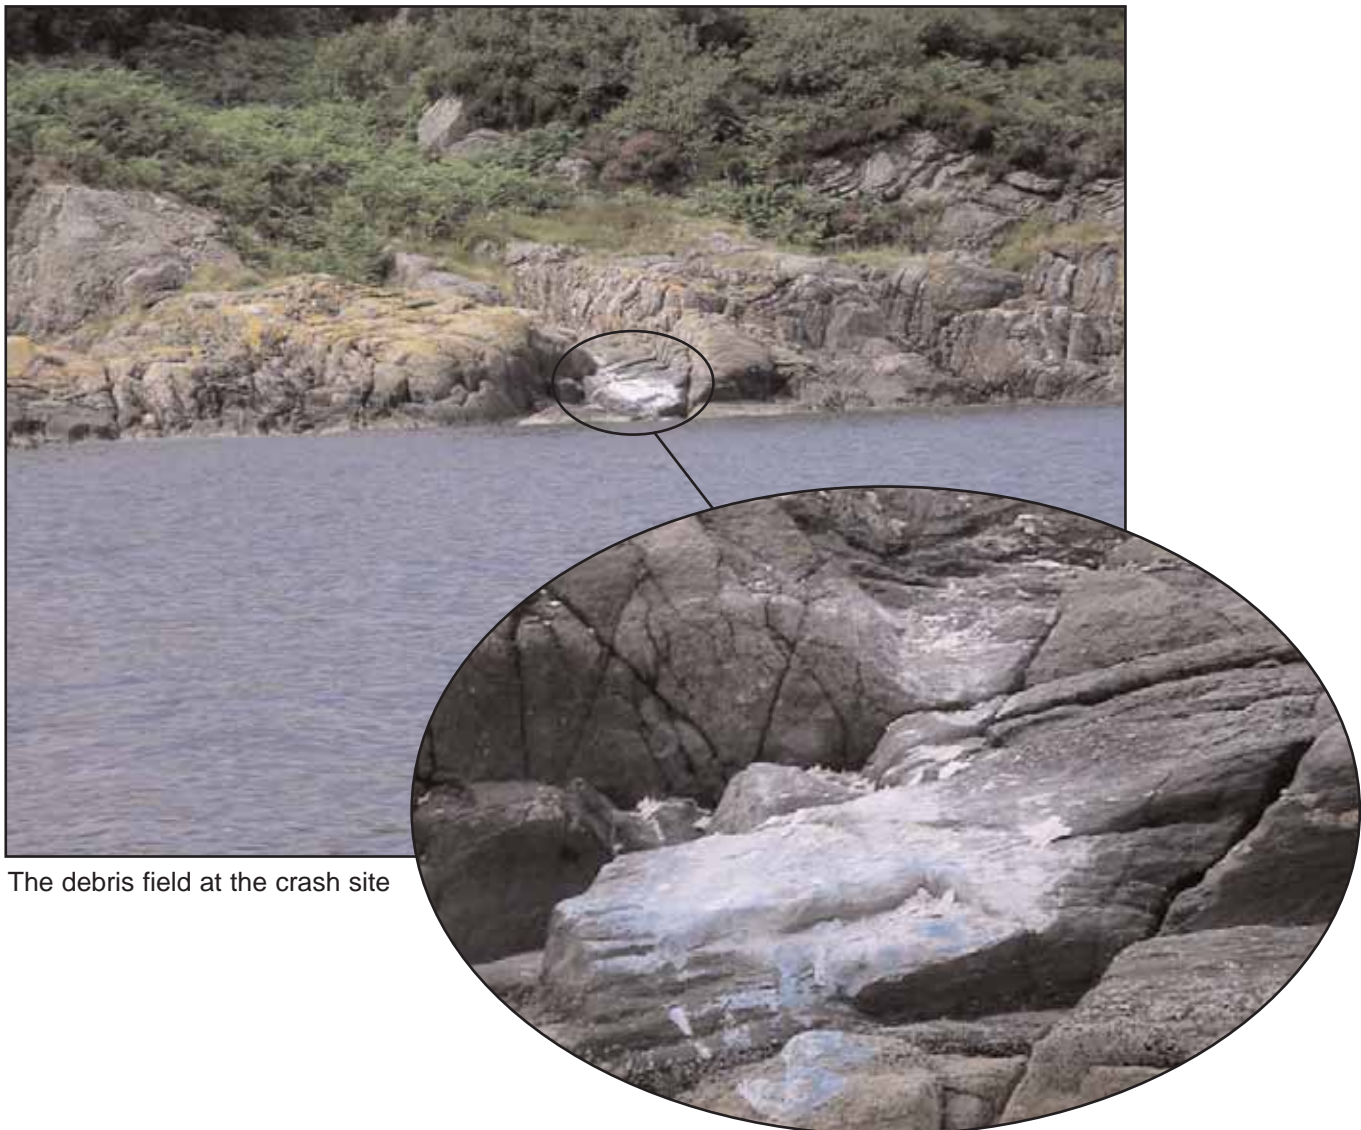
Figure 2

The forefoot of *Sea Snake* had grounded on the inclined rock just above the high water mark, and then slid down the rock back into deep water (**Figure 2**). With the boat floating, and her forefoot extremely badly damaged, she began to take on water.

The debris field at the crash site

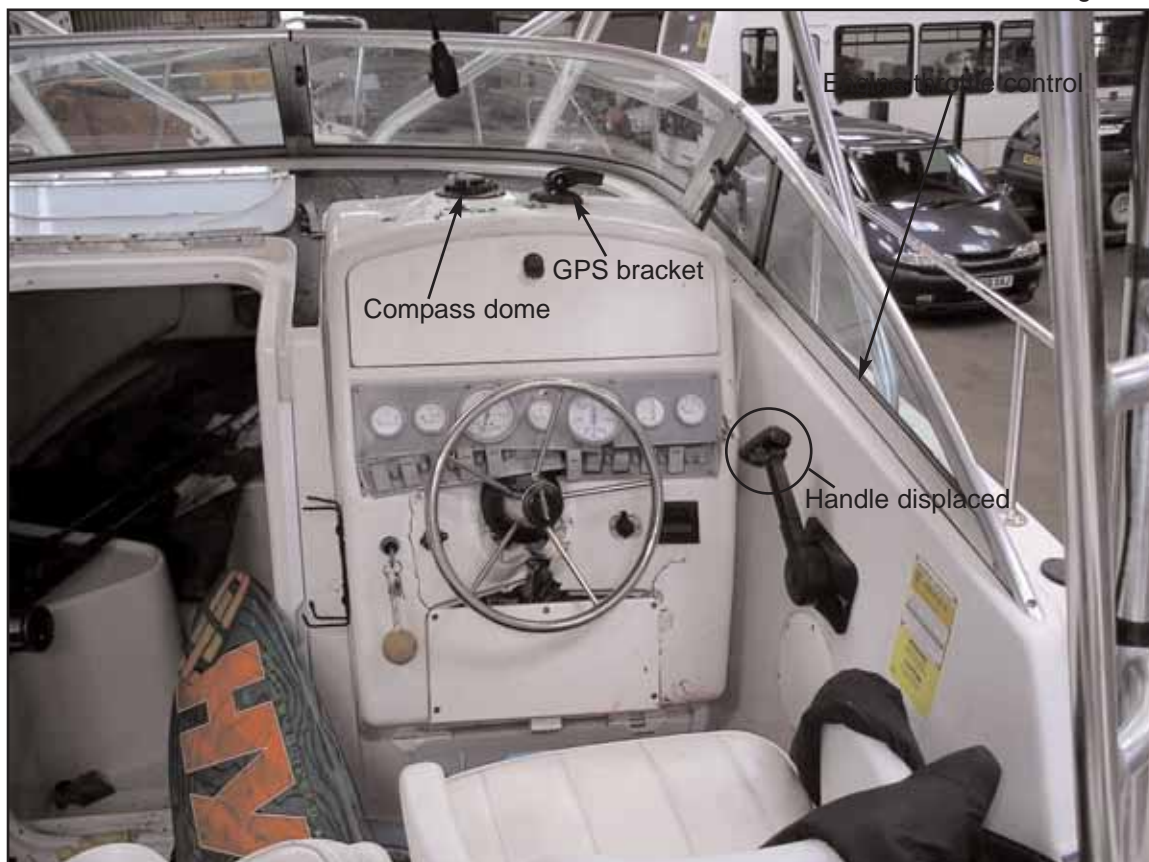
Figure 6a

The steering wheel had been pushed into the instrument panel, which was cracked and indented (**Figure 6a**). Although the steering wheel was displaced from its original position, the steering system operated satisfactorily. Consultants appointed by the police confirmed that the steering system was operable, and failure of the steering power assistance pump would not have restricted a helmsman's ability to steer the motor boat. The glass on the compass binnacle was smashed.

The door to the cabin was broken and had come away from its hinges (**Figure 6a**).

A photograph of the cockpit area showing damage to instrument panel, the engine throttle control lever and the companionway door

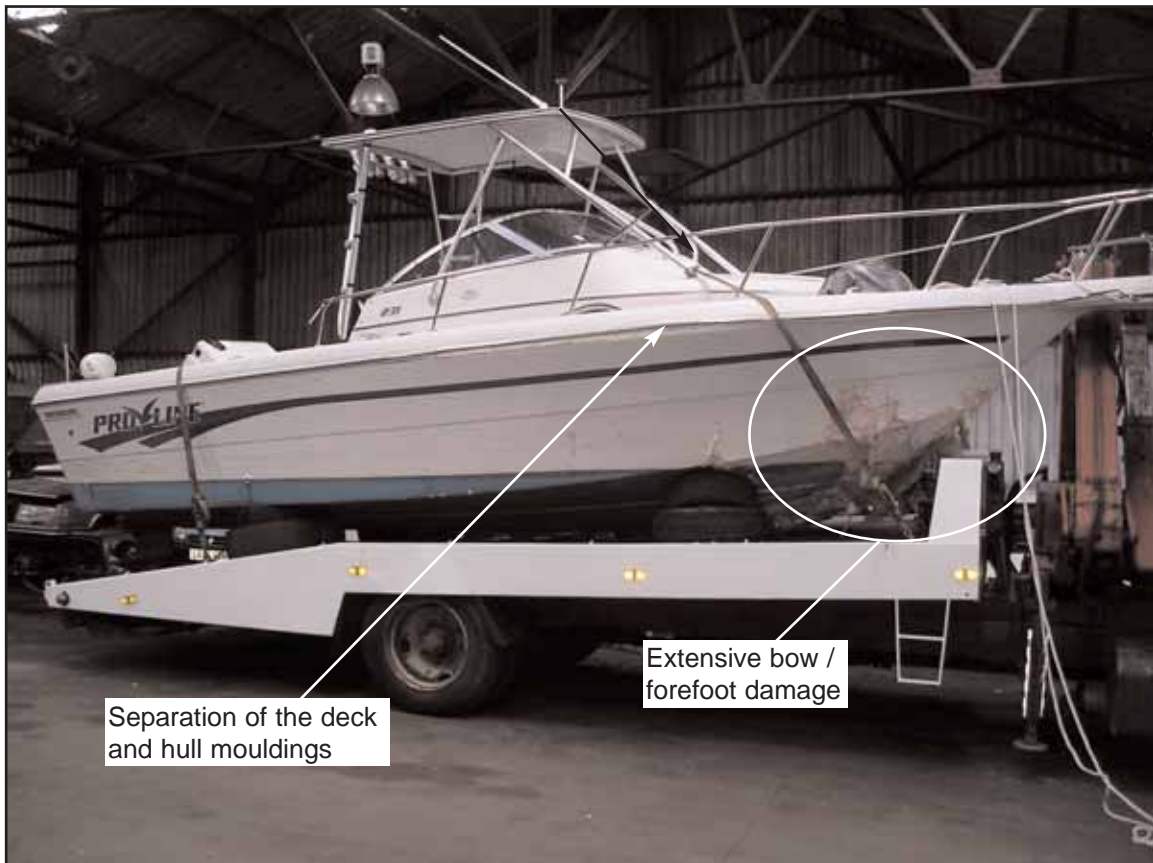
Figure 7

The fibreglass hull in the region of the forefoot, to 2m aft of the stem on both the port and starboard sides, had delaminated with the impact, and there were cracks in the hull radiating from the damaged forefoot (**Figure 7**). The forefoot was extensively damaged, and was open to the sea. The port side of the forefoot was damaged more extensively than the starboard side. The stowed centre line anchor was damaged and had been pushed to starboard.

Sea Snake stored in a garage

When *Sea Snake*'s forefoot hit the rocks, the forward part of her main deck parted from the hull, and there was extensive damage to the forefoot (**see Figures 7 & 7a**). The forefoot impacted the rocks above the high water mark, and the aft end took on sea water. The forefoot slid down the rock and the boat re-floated into deeper water. Afloat she began to take water through the damaged areas at the forefoot. By the time the yachtsman arrived, *Sea Snake* was filling with water, and was in danger of sinking, with everyone onboard.

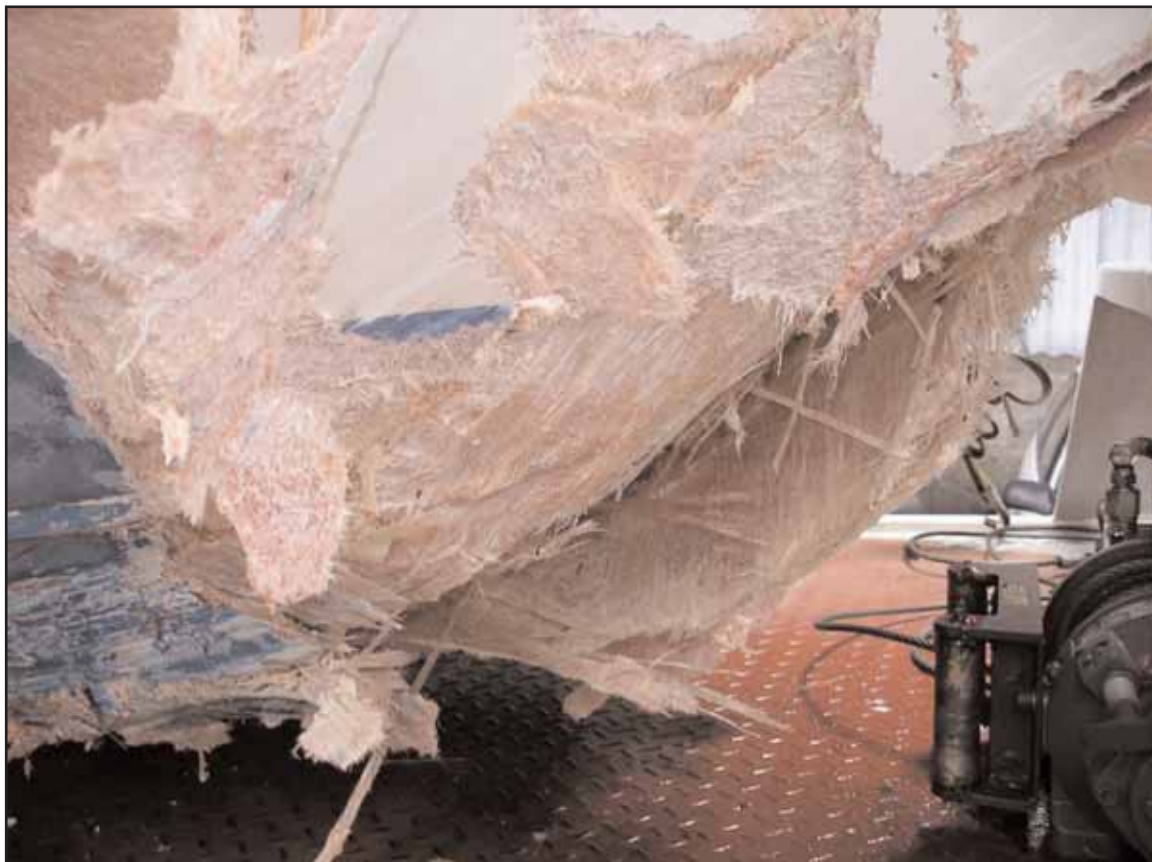
Figure 7a

Looking at the damage to starboard forefoot and bow forward

Sea Snake turned to starboard, and possibly only completed about 100° before impact. This is concluded from the damage on the port side of her forefoot being more than the starboard side. The damaged anchor being dislodged to starboard is also consistent with this, so, too, is the yachtsman's account of seeing only the red navigation sidelight before she went out of sight behind the rocky island of Eilean a Choic.
