Network Rail

Summary report of the investigation into the train derailment of 1S83, the 17.15hrs Virgin Pendolino train from London Euston to Glasgow

Date:	23 February 2007
Location:	Lambrigg, nr Grayrigg, Cumbria

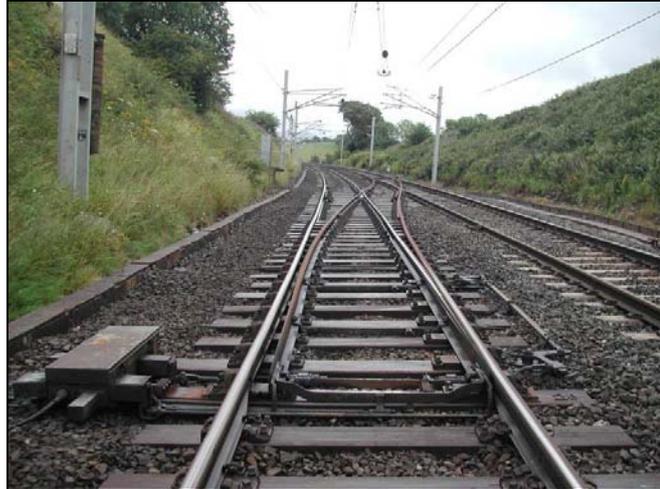
General view of Lambrigg GF, 2B points in the foreground, looking eastwards (July 2004)
