Report on the investigation of
the grounding at high speed of the leisure powerboat

Sea Snake

near the entrance to Tarbert harbour, Loch Fyne

Report No 10/2006
March 2006

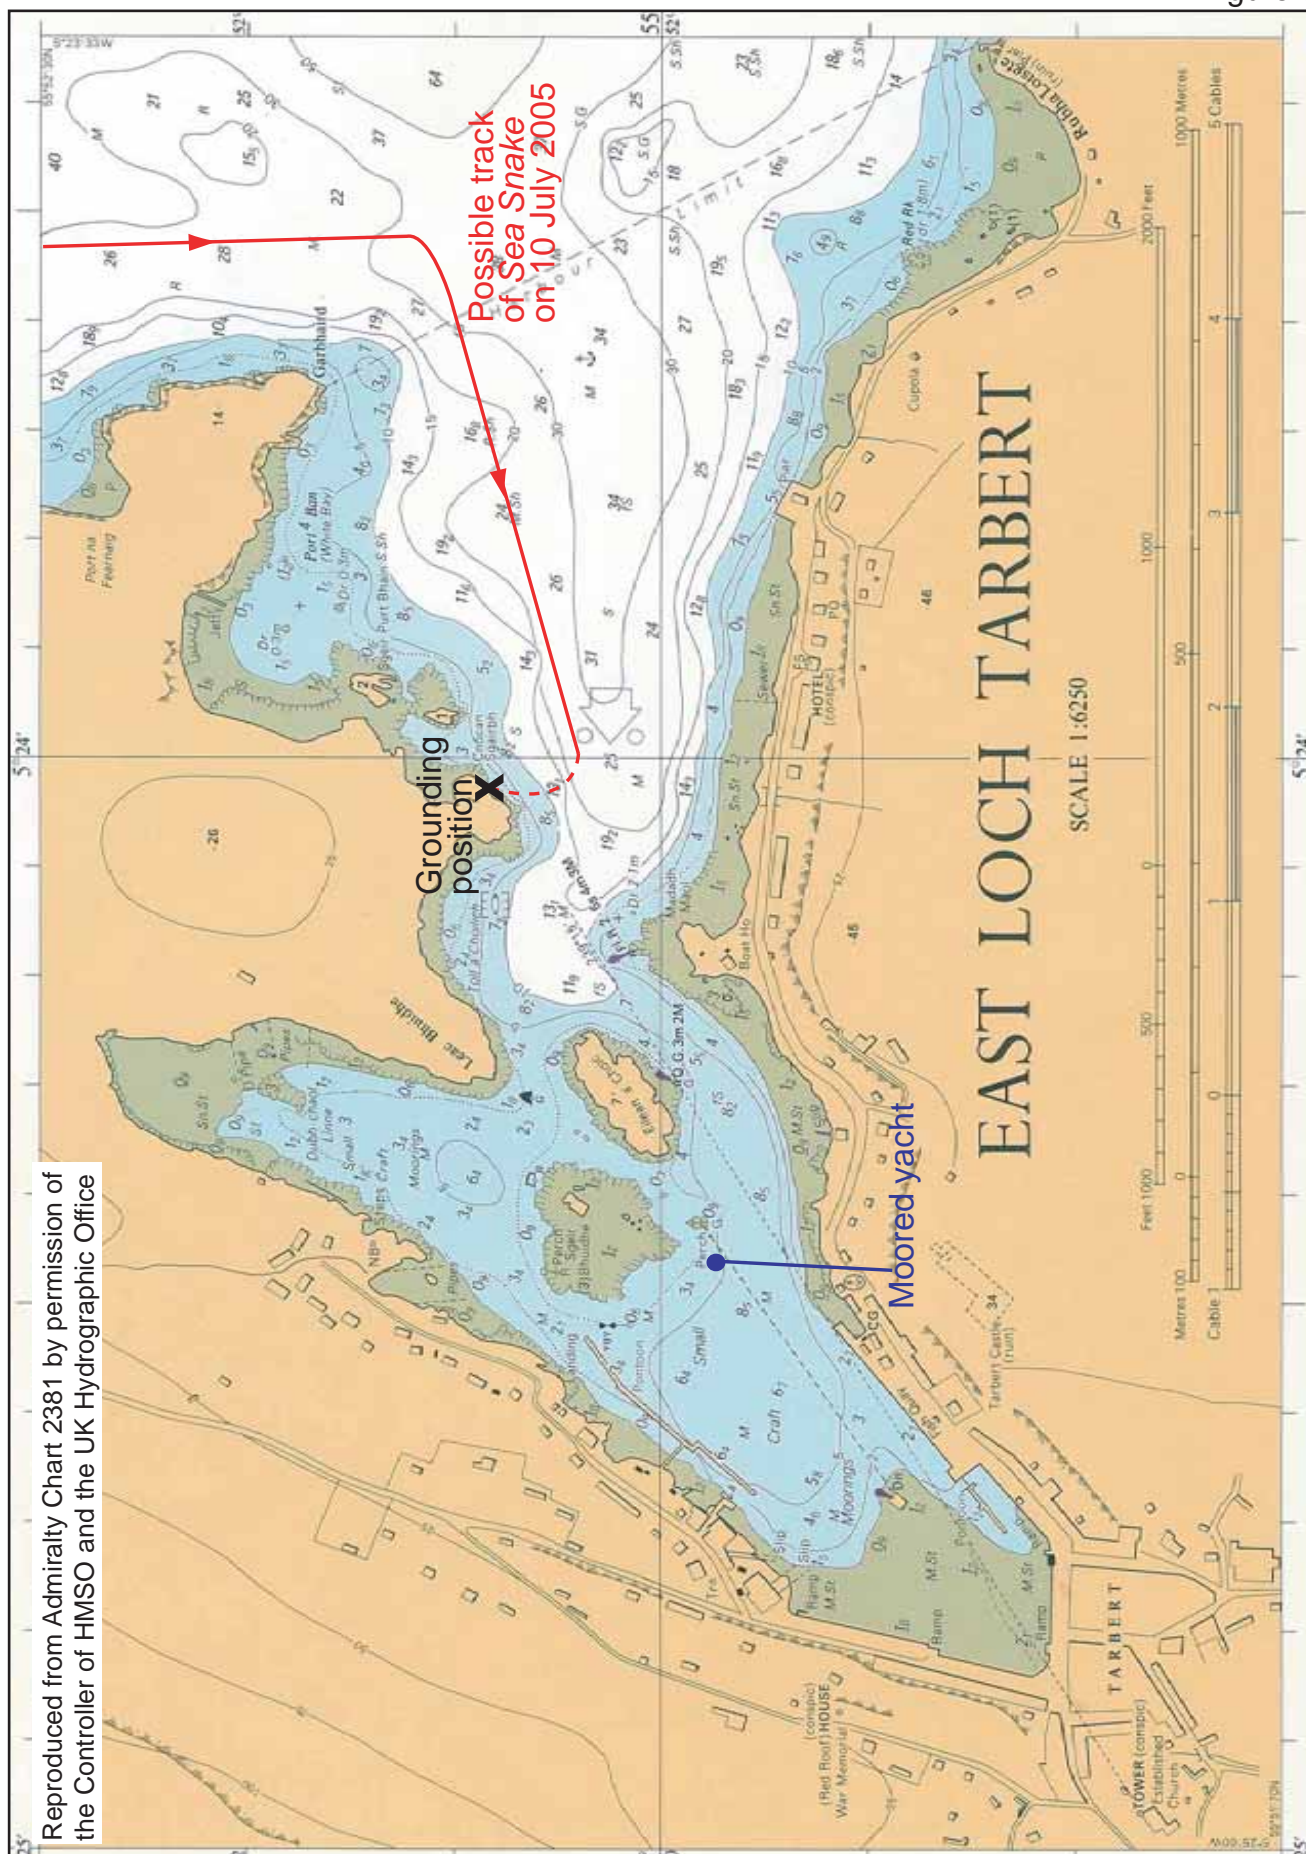
Figure 3

Meanwhile, from a house overlooking the outer harbour, people watched as the white navigation light of a motor boat approached the inner harbour from Loch Fyne, and then disappear. Sensing this needed further investigation, they used their car headlights to illuminate the area, and saw the boat across the water, without its lights on. All was quiet; the engine was not running. They called out, but no-one replied. They flashed the lights and shouted out again. This time, a man's voice was heard appealing for help. One of the observers rowed a dinghy from the inner harbour to the ferry slipway at Madadh Maol. By that time, two ambulances, police officers and coastguard auxiliaries had arrived at the slipway. Two police officers and the coastguard sector manager boarded the dinghy and rowed out to the accident site (**Figure 3**).

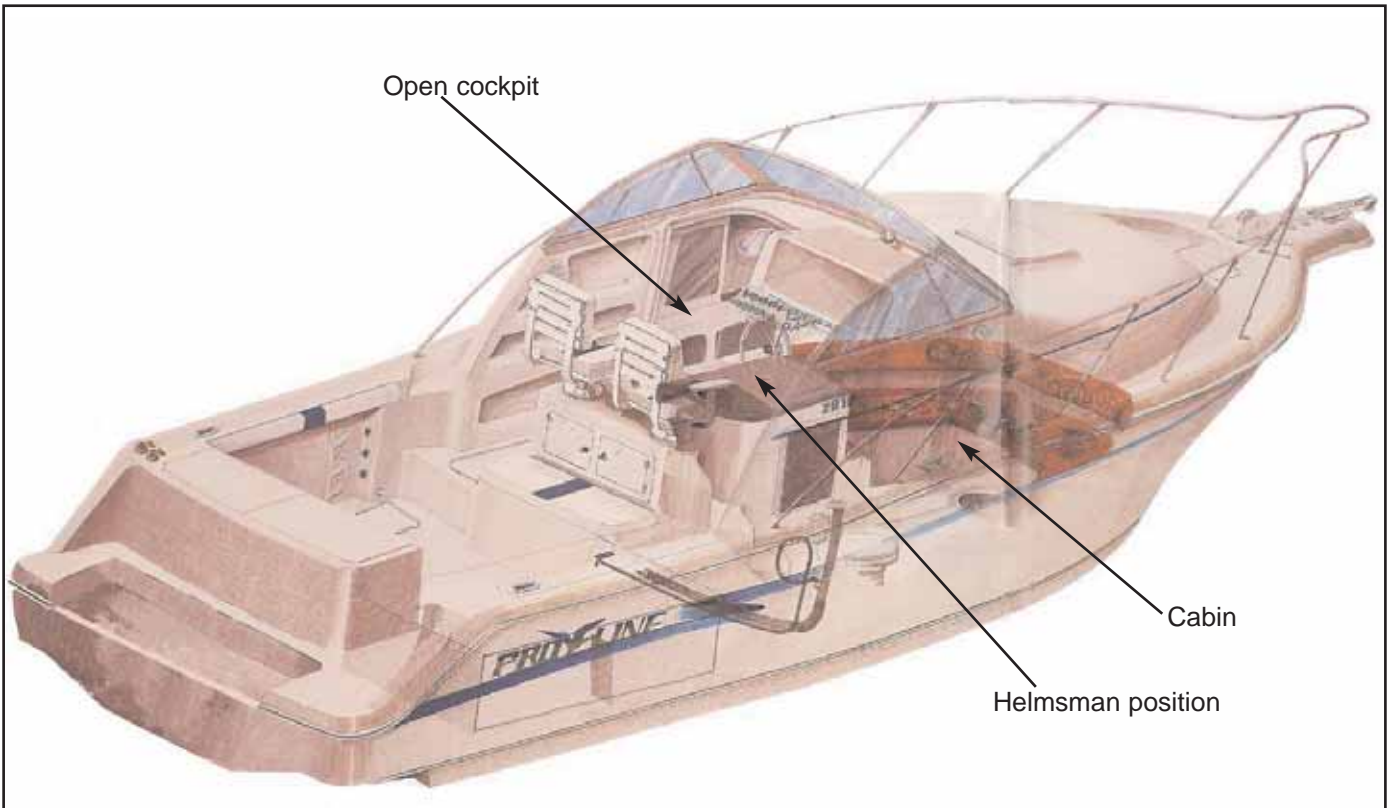
Figure 4

Sea Snake was built by Pro-Line in Florida (USA) in 1997 as a "sport fishing boat", with a model label of *231 Walkaround*. The motor boat had the capability of being a weekend cruiser with the provision of a two berth cabin forward (**Figure 4**).

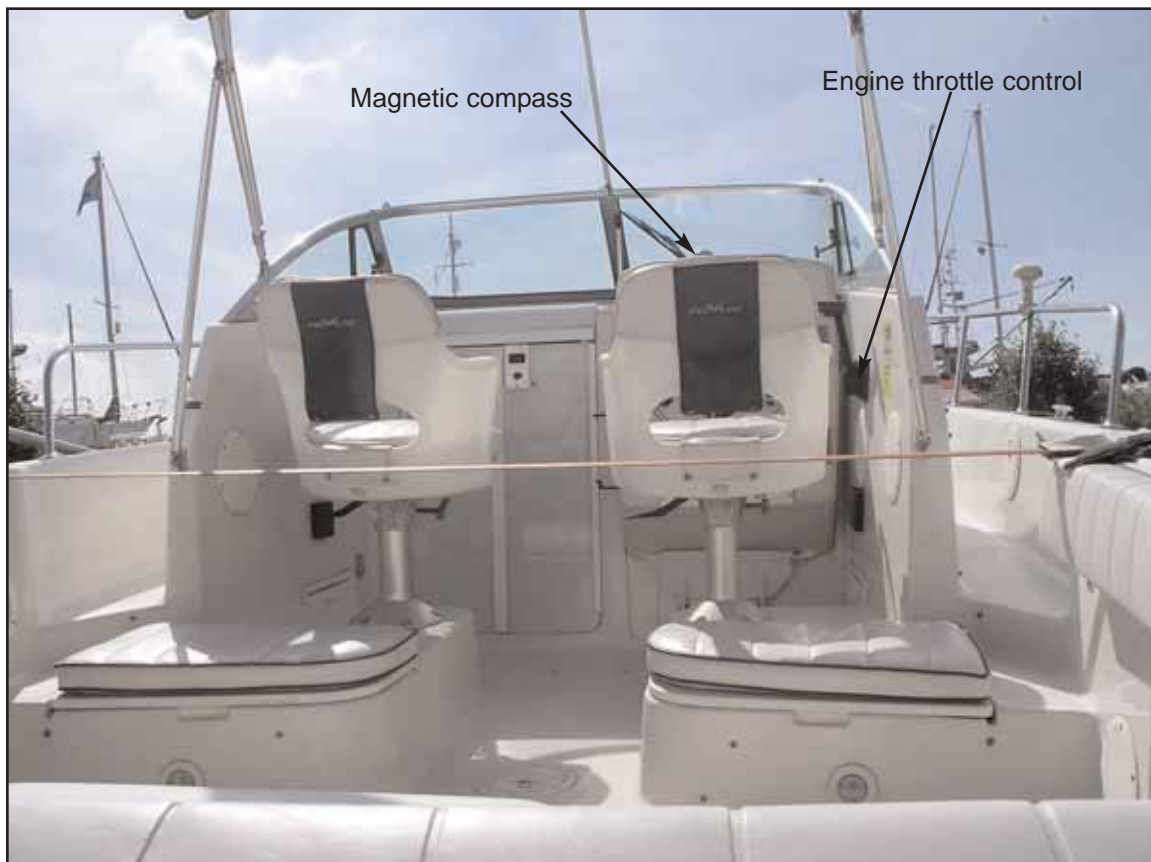
Figure 5

The large cockpit was laid out as shown in **Figures 5 & 6**, with the helmsman's position forward and on the starboard side. There were passenger seats forward on the port side and aft of the helmsman's position.
